Historic Farm Buildings in the 21st Century: Adapting to a Changing Landscape

A thesis submitted in partial fulfillment
of the requirements for the degree of:

Master of Arts in Historical and Sustainable Architecture

New York University

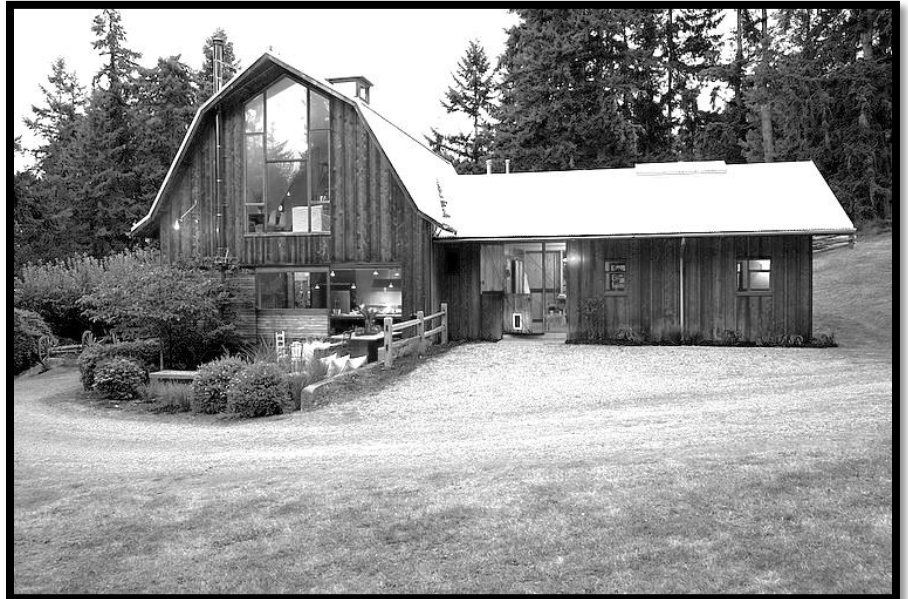
Figure 3: This converted barn on Whidbey Island, Washington, USA looks a bit too much like a house. Image is “Oh yeah” by Jenna Elia Pfeifer.

becomes a home, there are numerous things that have to change. Many openings are often created to make new windows where there were few or none before. Barn doors are typically too large and unwieldy to be used on a daily basis, so a new human sized door is cut. Chimneys and vents are added to the roof, perhaps a deck is added on the side, and soon the simple, utilitarian form of the barn is broken up with numerous new additions that in no way invoke its agrarian past. While continued agricultural use would be best, and a use which keeps the fabric unchanged preferred, sometimes domestic conversions happen, either because there was no other way to save the building or because someone just did not know better.

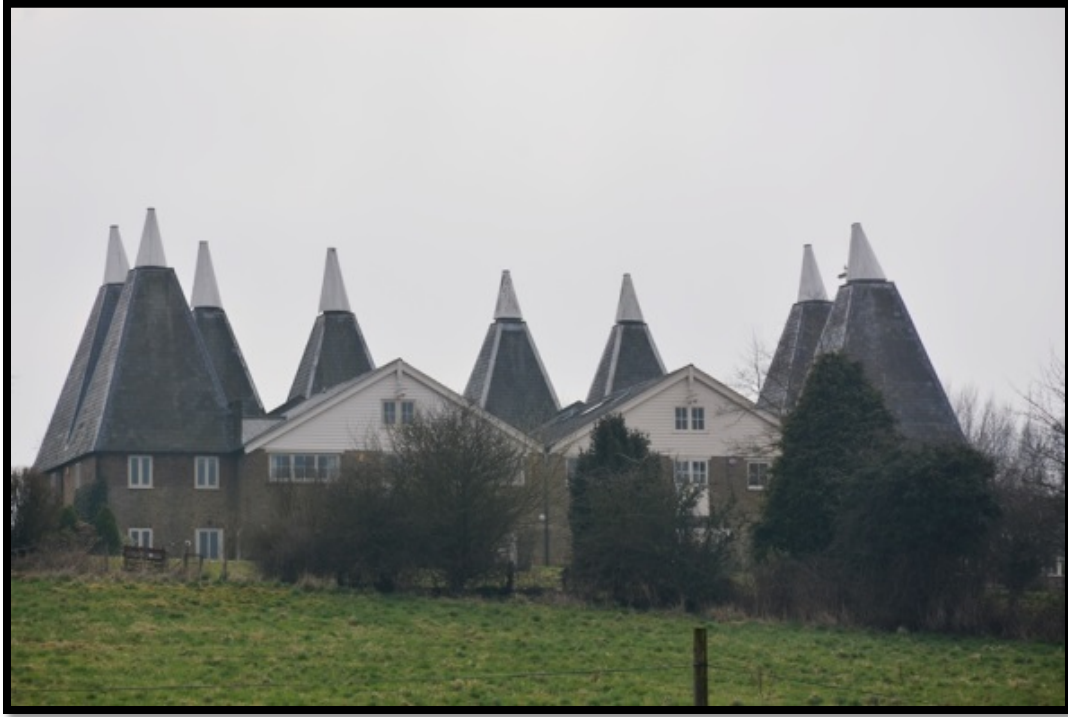
Figure 7: This large complex of oast houses near Maidstone has undergone a domestic conversion.

Hops became a common crop in Kent and Sussex in the fifteenth century, and their cultivation developed until, as early as 1574⁹, artificial drying in a kiln was recommended because the process of natural drying was unsuitable for large yields. These hop kilns are known as oast houses. Complete oasts have storage space for green hops, the kiln, and another storage space for dried hops waiting to be packed. The characteristic cowl was invented in the 1790's as a device to block the wind and allow air to circulate below; it rotates through the use of a weather vane¹⁰. The majority of surviving oast houses date from the nineteenth century.

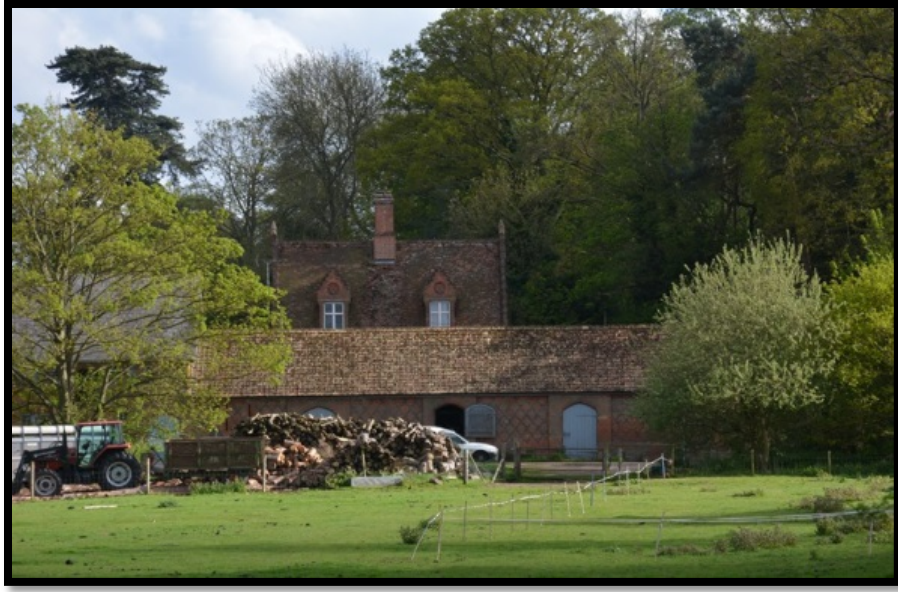
Figure 16: A farm near Manningtree with elaborate brickwork.

Examples of historic farm buildings can be found along the path to Flatford. Near Manningtree train station there is a beautiful brick farmstead not which appears to be in traditional use, if only as stables and storage. The remarkably elaborate brickwork and cohesive design of the farmstead with a single, continuous material, suggest that it is Victorian.

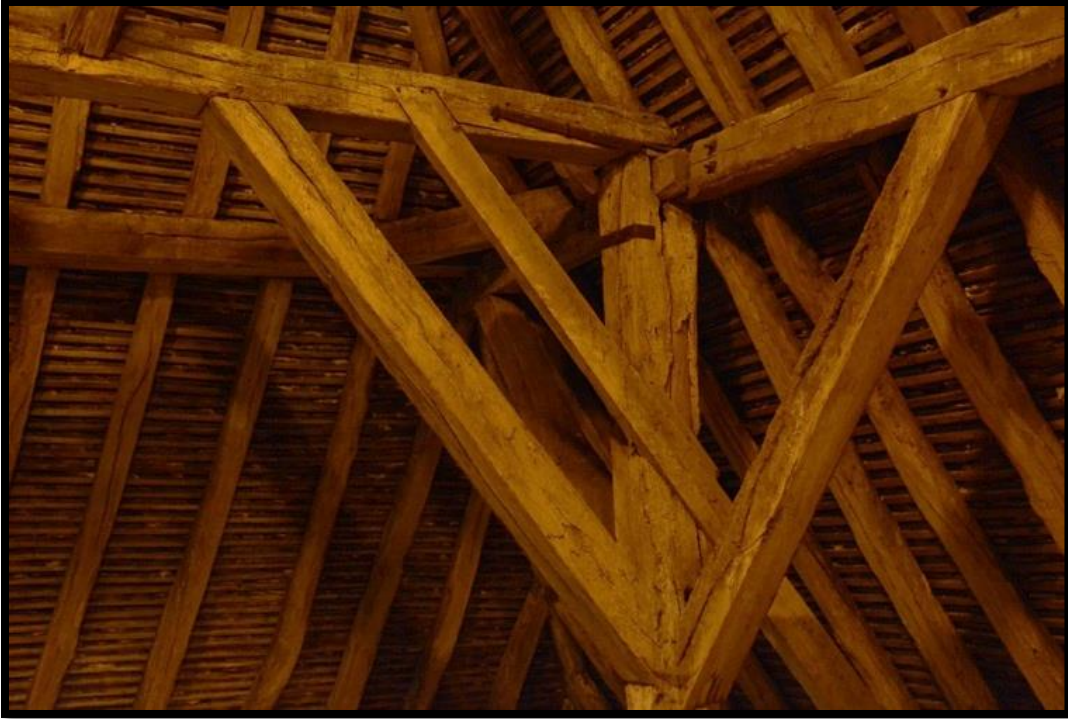
Figure 18: A detail of the structure in the Wheat Barn at Crossing Temple.

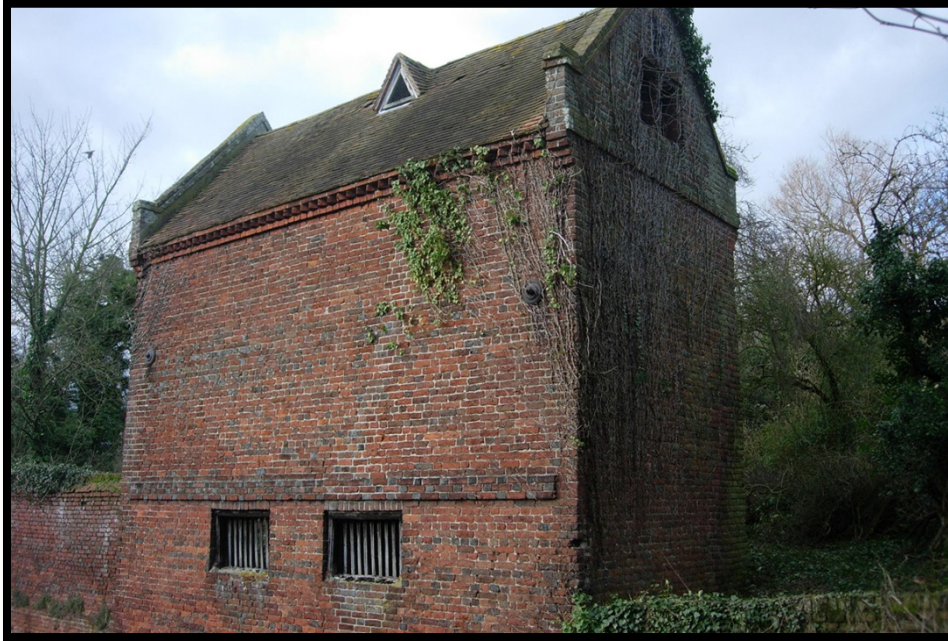
Figure 19: The condition of the dovecote is getting increasingly worse. Image from Historic England.

The dovecote is a three story building intended to house pigs on the first floor, hens on the second and doves on the third. The body heat from the pigs warmed the entire building, keeping the poultry comfortable in colder months. It is built into a hillside so both the pigs and the hens enter at ground level. After a fire around 1700, Burnt House Farm was rebuilt to a careful plan; it includes fine brickwork throughout which gives it a unified feeling. The entire farmstead survives and is listed Grade II, but only the dovecote is a Scheduled Ancient Monument.

Today, though all the other buildings on the farmstead remain in good condition, the dovecote is on the Heritage at Risk Register. The building is now vacant and in poor condition; it is prioritized as grade B, a category defined as, “Immediate risk of further rapid deterioration or loss of fabric; solution agreed but not yet implemented.”²⁷ The listing states that there is a new owner who plans to repair the building for low-key use.

The problem facing the dovecote is one of funding. The characteristics of piggeries, poultry houses and dovecotes make them difficult to reuse on a modern farm because they tend to have low ceilings, small doors and little ventilation. The dovecote at Burnt House Farm is in private ownership and it is unreasonable to expect the owners to divert funds to the maintenance of a building whose design – while highly functional at its inception – has rendered it largely useless. Historic England can list the building as a Scheduled Ancient Monument, but this status alone will not protect it: if they do not ensure that there are resources available for the upkeep of the building its condition may still decline.

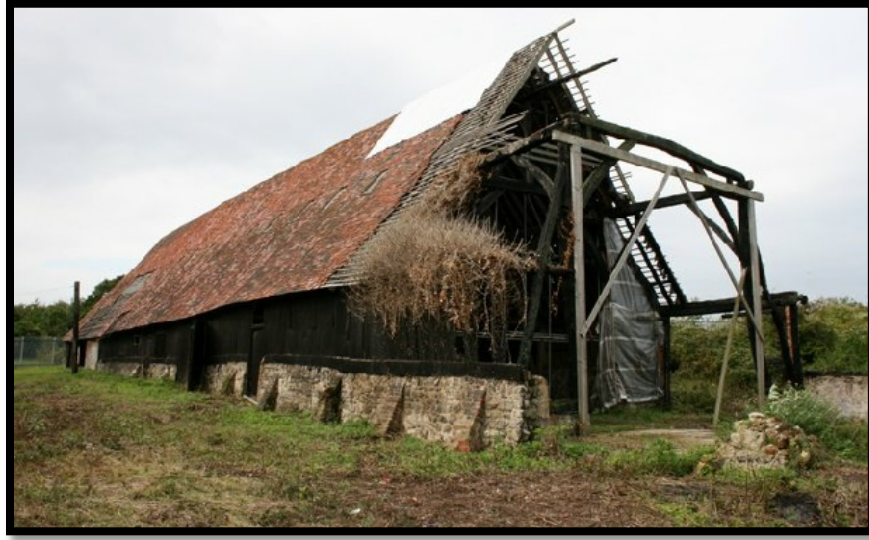
Figure 20: Frindsbury barn after it sustained fire damage in 2005.

A second significant building at risk is Frindsbury Barn, located near Rochester, Kent. The barn's Grade I listing proves that it is of great importance. Built around 1300, it is the longest medieval timber framed structure in Great Britain²⁸. In 2005, a series of fires destroyed four of its fourteen bays.²⁹ The SPAB gave financial help to fund emergency repairs that would secure the building. Though these repairs were successful in slowing its decline, it remains on the Heritage at Risk Register. Previously in priority category A, "Immediate risk of further rapid deterioration or loss of fabric; no solution agreed"³⁰, it has since been changed to category C, "Slow decay; no solution agreed"³¹, largely thanks to SPAB funding. It is, however, entirely shocking that after ten years, no solution for the repair and future use of this important building has been agreed upon, though the Heritage at Risk entry indicates this is under discussion³².

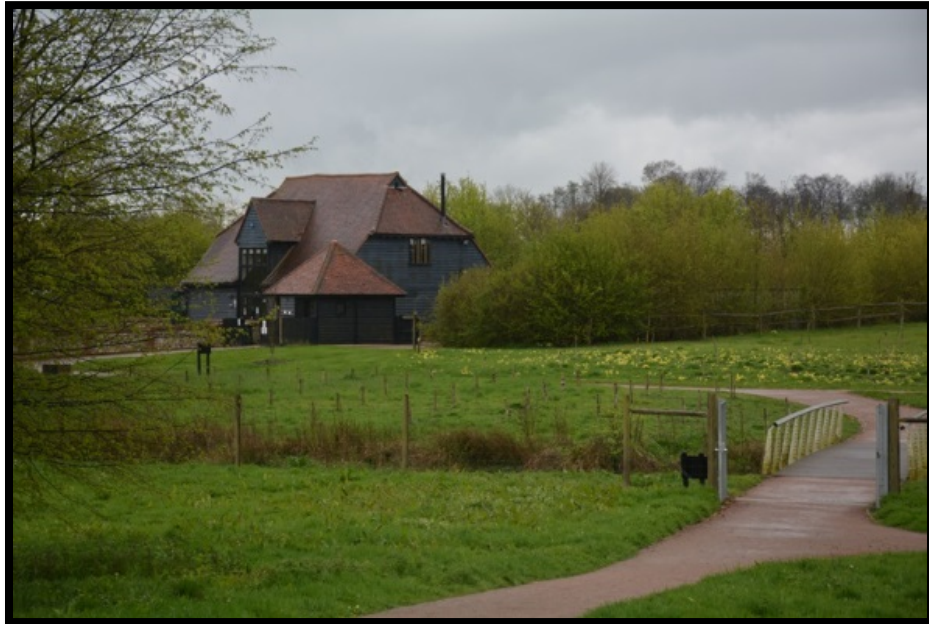
Figure 22: The barn at Marks Hall Garden has been converted into a visitor's center. Though its use is new, it still stands beside agricultural fields.

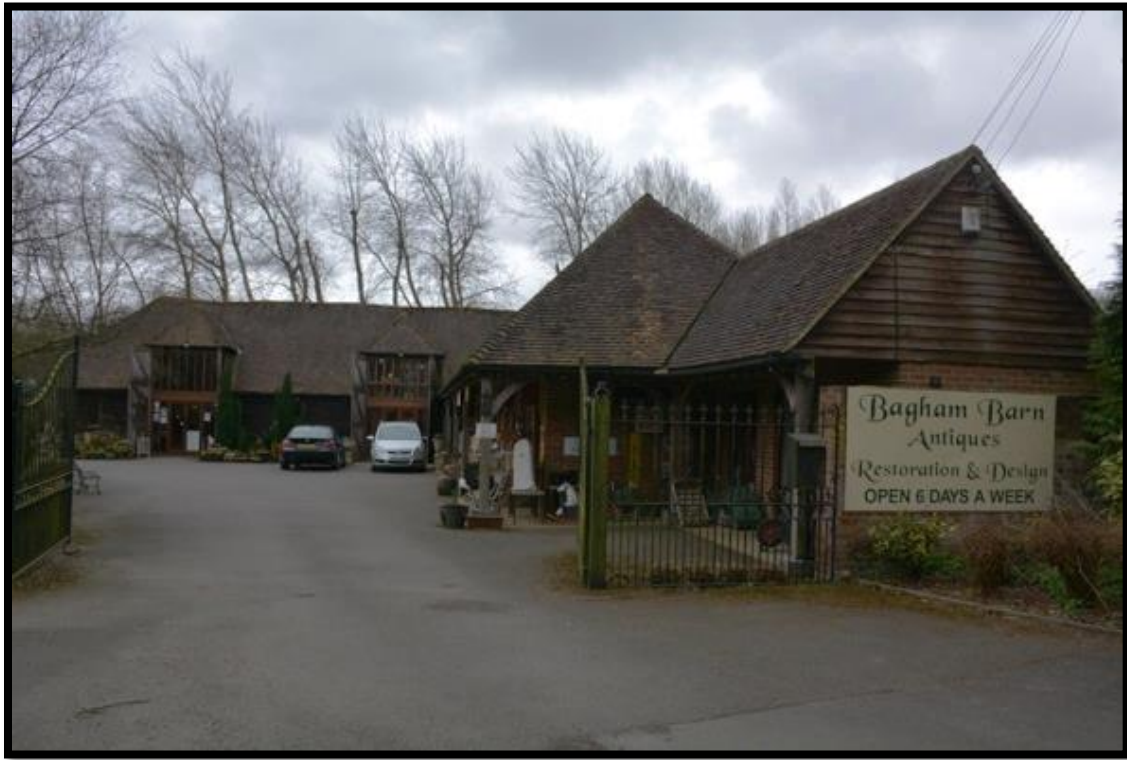
Figure 23: The main entrance to Bagham Barn Antiques.

Bagham Barn is a Grade II listed 17th century barn near Chilham in Kent³⁶. The structure is timber frame with a tile roof, weatherboarding and a brick base. Fifteen years ago, it was derelict³⁷. It had been removed from agricultural use and was not in a position where it could be used on a farm again: all around it was built up, with train tracks on one side, a busy highway on the other and a school and warehouse on the third. Only one side remained a field, though a road ran through that only about fifty yards from the barn.

To turn the barn into a place which could house a business, much work had to be done. The roof was partially collapsed and much of the structure appeared to be rotting³⁸; it was unusable for any purpose, let alone as a showroom for expensive antiques. The planning permission from the beginning was for a store; presumably the local authority considered this an acceptable way of saving the barn from the brink of destruction. It is lucky that this barn even found a new use, since its noisy location meant no one would have wanted it for a home. Instead it became a business and what resulted was a successful, and overall well done, renovation that restored the building in a way which kept it looking like a barn.

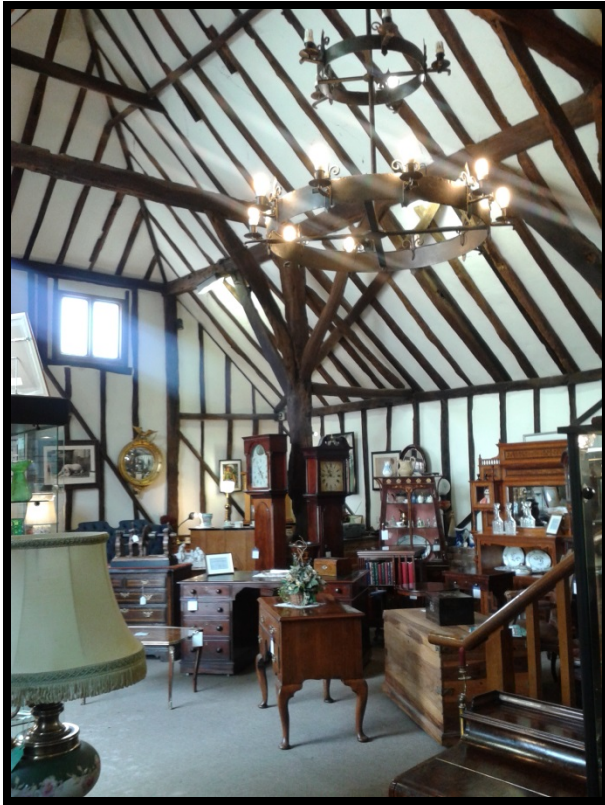
Figure 24: The main, double height space in Bagham Barn. The structure remains visible and it is open to the ceiling.

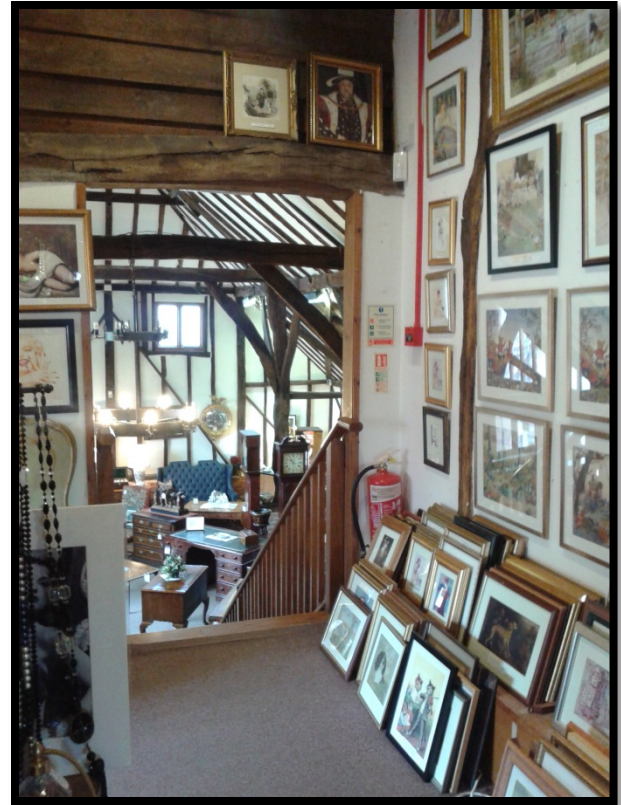
Figure 25: A view of the main space from the mezzanine level.

Unfortunately the barn also has secondary spaces where the renovation was not completed to the same standard. In these rooms you may as well be standing in a newly-built furniture show room. There are no original elements visible and the only way you might know you are in a barn is if you look out the window and see the rest of it. This area of the barn, which mainly suffers due to the beams being drywalled over, had previously suffered the worst damage. Before the renovation, this area was almost entirely collapsed. Much of the original fabric may not have been salvageable and in this situation it is enough that the barn looks intact from the outside and the main spaces keep original elements.

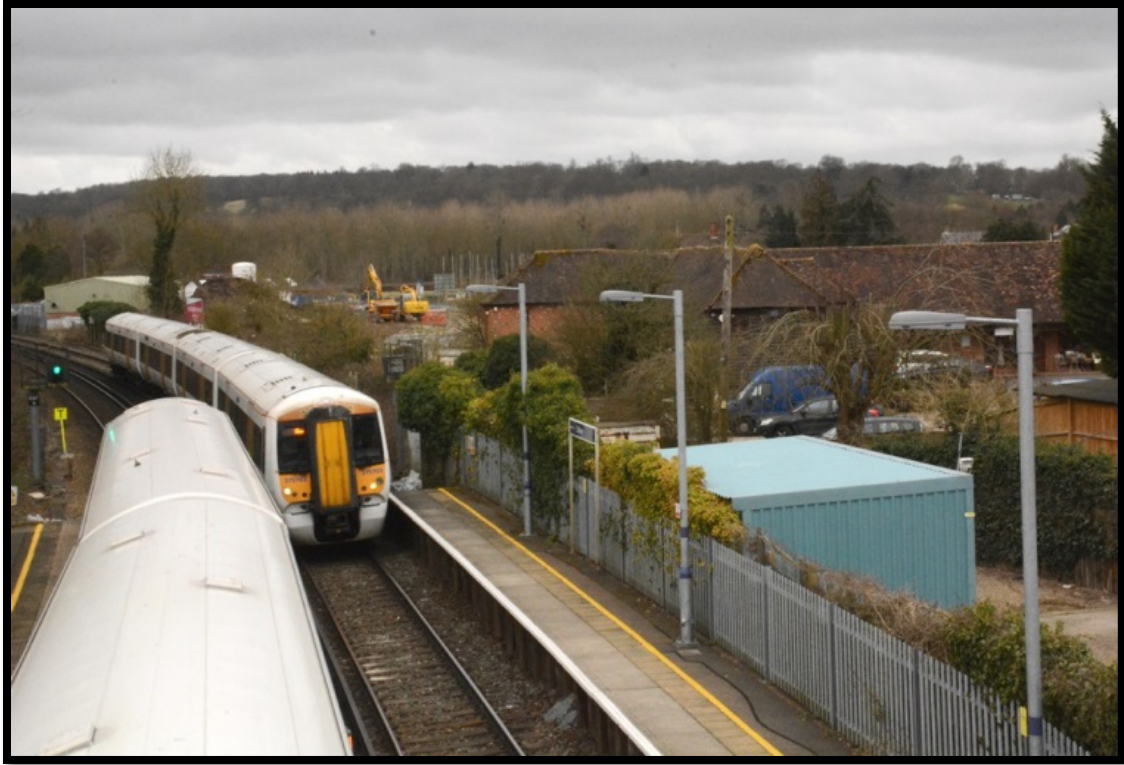
Figure 26: The roof of Bagham Barn can be seen in this photo and the new construction is visible in the background. Also shown is how close the rail road is to the barn. This image shows how entirely ruined the barn's context now is.

Recently, the last remaining open field beside the barn has been developed for housing. In March foundations had already been laid for numerous single family homes, terrace houses and apartments. This final development will entirely ruin the barn's context with its surroundings. No matter how good a renovation is, if the relationship to the landscape is destroyed, it will never truly look like a barn again.

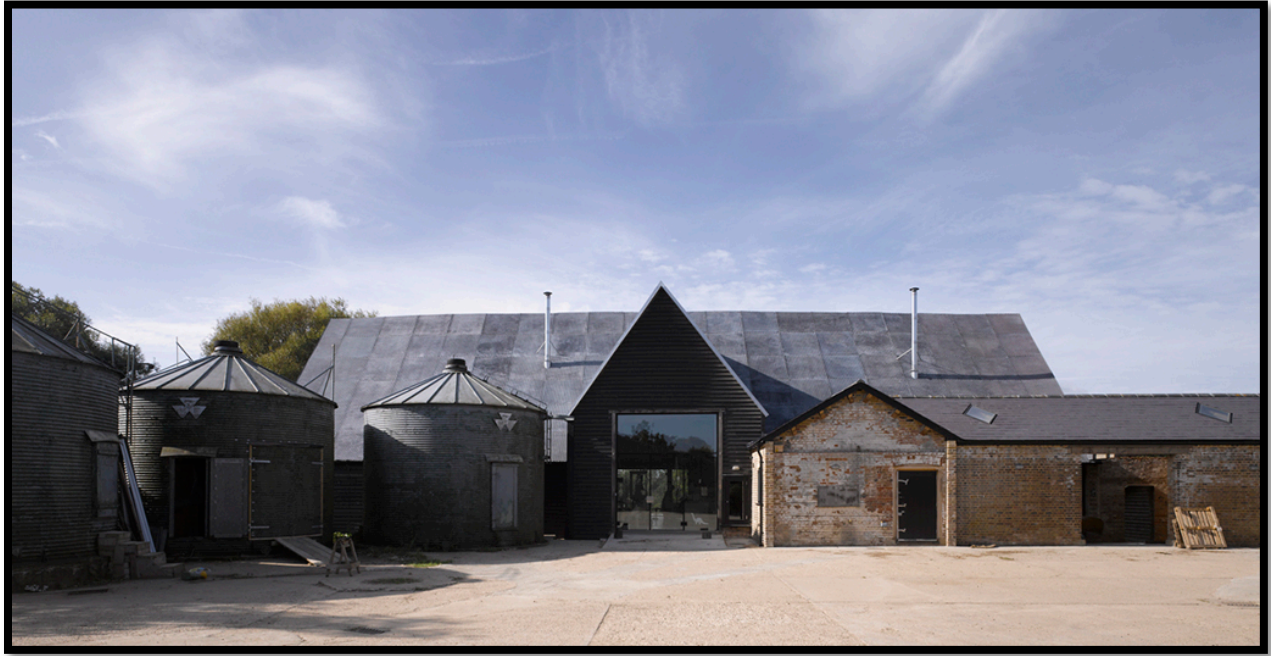
Figure 27: The barn at Feeringbury Farm after the renovation. The new doors are visible as is the highly innovative roof. Image from Goodfellow Communications.

This couple was perfect for turning a barn into home. From the beginning, they wanted none of what they referred to as "nice-ification"⁴³. They wanted to maintain as much of the historic fabric as possible – even when it was far more difficult to do so – and they did not want to build a cozy place within the large space. They refused to insert a large second level, and instead essentially built a house at one end of the barn out of old grain silos they found previously stored in the barn.

The initial budget for the renovation was £650,000, but they spent £800,000⁴⁴. This was largely due to their diligence in maintaining the historic fabric. Not only were the two six and a half foot wide silos reinserted, one as a bathroom and one as a staircase, but the mezzanine they created is made of recycled wood and iron. The owners reused as many found objects as possible, turning things like a pipe into a shelving bracket. All the new insertions were made perfectly plumb to show how distorted the original structure has become⁴⁵.

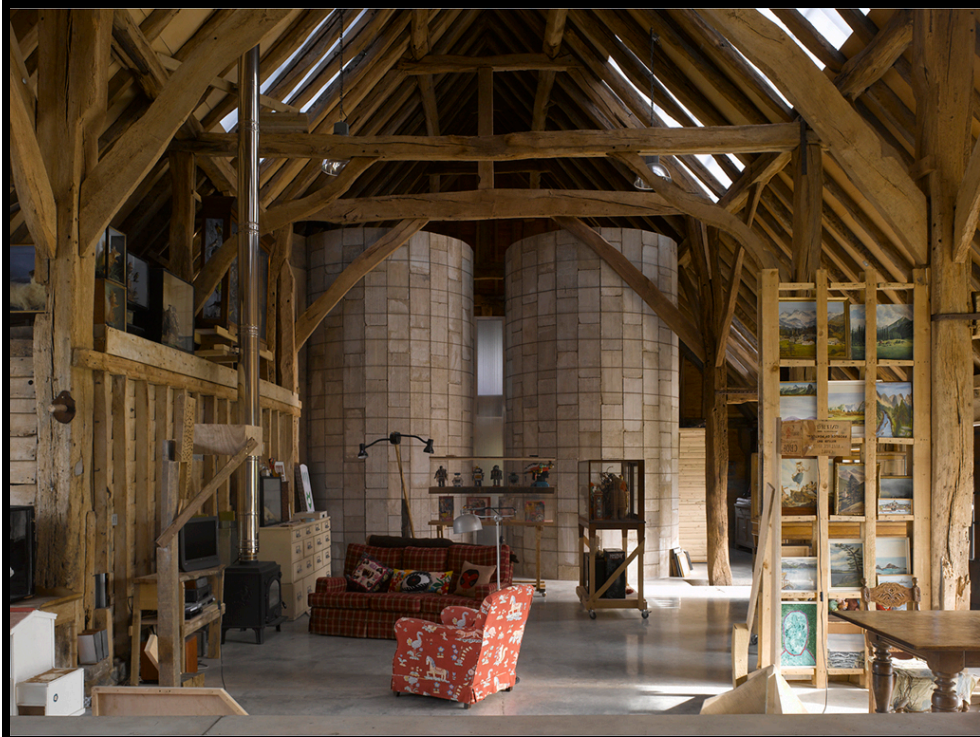
Figure 28: A view of the interior of the barn showing the silos inserted at one end to create a separate space. Image from Goodfellow Communications.

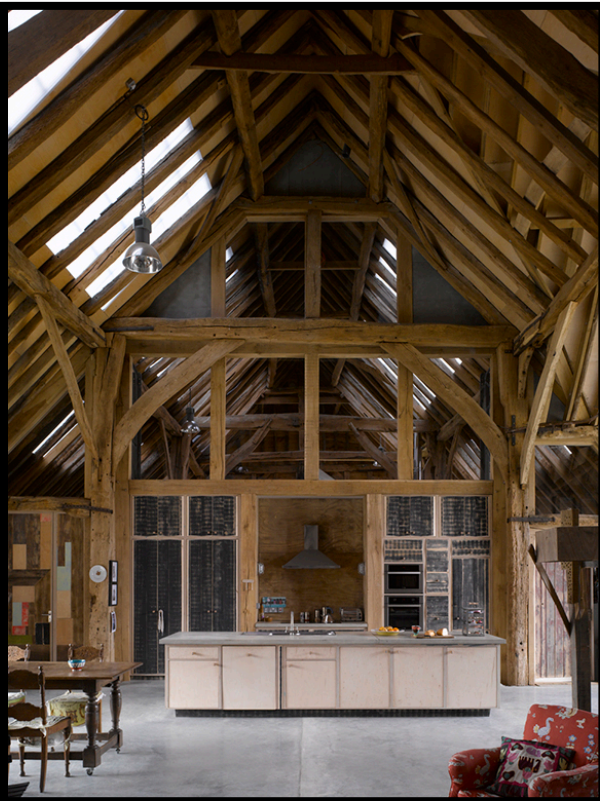
Figure 29: The interior of the barn towards the work space, which is just beyond the partition. Image from Goodfellow Communications.

The barn was repaired in Georgian times and at that time inferior softwoods were used. The conservation officers nonetheless insisted as much of the structure be kept as possible, so the owner was forced to splice a new piece of good wood with the bad, something Ben considered, "making the wrong wronger"⁴⁶. It may go against his beliefs, but it still left him with a beautiful result.

added to the cost was insulation. The owners wanted the structure to remain visible from the inside, just as it has always been. In order to achieve this all of the weatherboarding was removed from the exterior of the barn, 125 millimeter fiber board insulation was installed, and finally new weatherboarding replaced on top⁴⁷. This painstaking process cost quite a lot, but the results were certainly worth it; the exposed structure on the inside is absolutely stunning to look at and keeps it feeling like a barn.

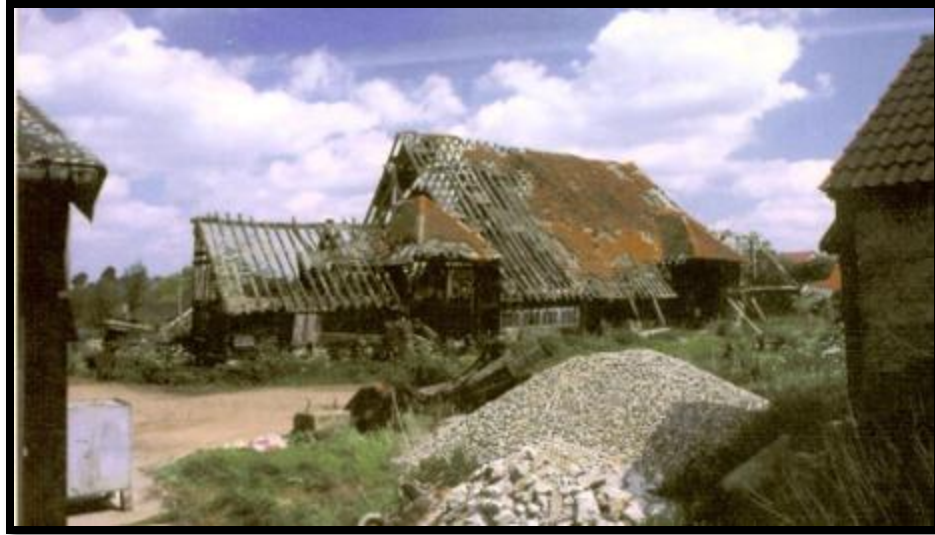
Figure 31: The Grange Barn at Coggeshall shortly before it was compulsory purchased. Image from the National Trust.

Saving Coggeshall from destruction was a seventeen year long fight; the owner wanted to build houses on the land, and wanted to demolish the barn to make more room even though it was already listed⁴⁸. Eventually it was compulsory purchased by Braintree District Council, though it was later handed over to the National Trust⁴⁹. The barn was in an extremely dilapidated state when it was finally purchased, and numerous repairs had to take place. The biggest problem was deciding the philosophy for repairing it, but in the end they did only repairs with no conjectural rebuilding, except at one end where they found original structures⁵⁰. The barn is now open to the public and can be rented for various events such as weddings. In warmer months, theater performances are often held here.

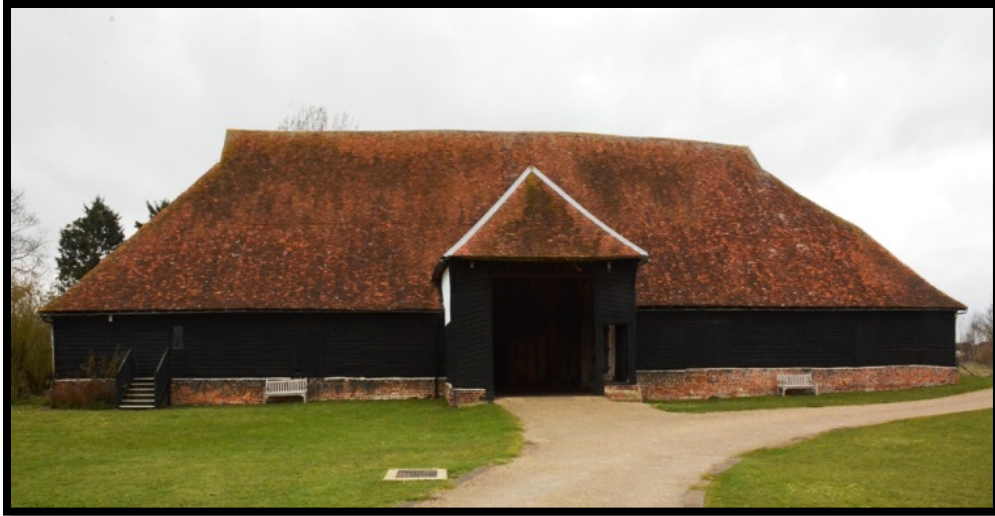
Figure 32: The Barley Barn at Cressing Temple.

In the case of Cressing Temple, the owner was far more helpful and wanted the county to purchase the buildings rather than see them go into decline⁵¹. It was sold to Essex at a knockdown price and has become a symbol of the county's desire to preserve history. Shortly before the purchase the barns sustained storm damage and repairs had to be carried out⁵². Today half of the wheat barn has a museum inserted into it with a mezzanine level looking out over the space. This museum gives interesting information and is worth having, but it is unfortunate that it breaks up the space. The barley barn remains one open space and is absolutely stunning to stand in.

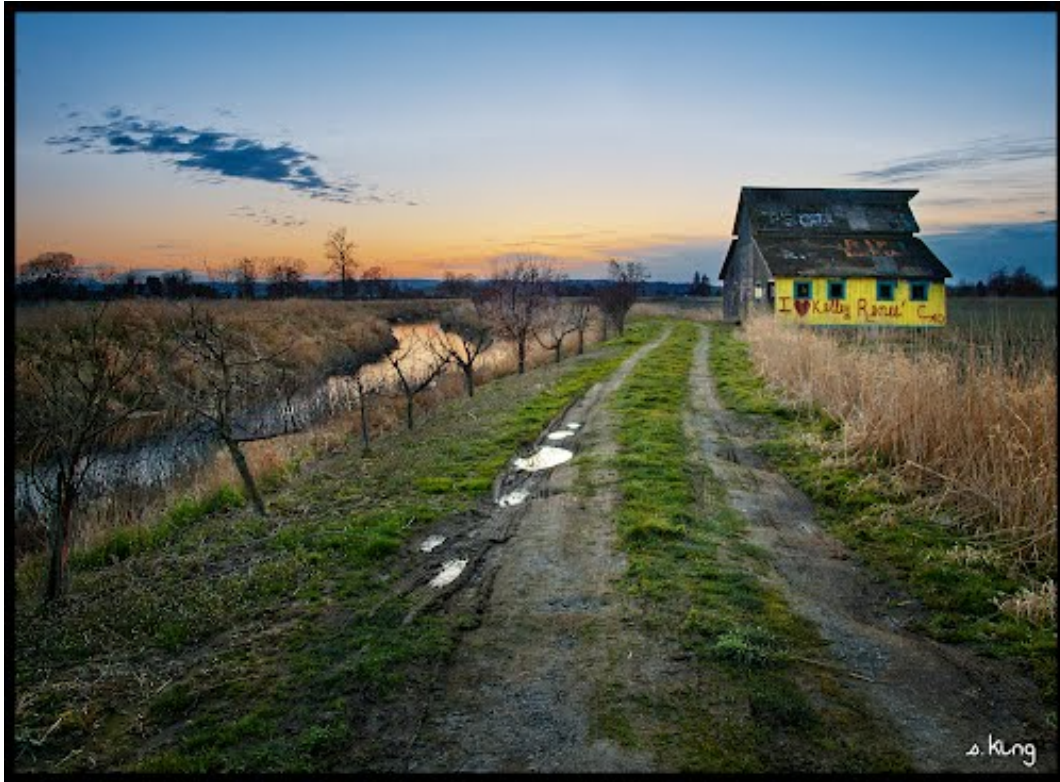
Figure 35: The Stanwood Memorial Barn. Image by S. King.

The example given here was not even on the register, though it was likely built around the turn of the last century. Its condition had deteriorated so much by the early 1990's that it was used only to store a dead tractor and other forgotten equipment. This building is an example of

an old dairy barn, though most barns of this era and in this region were built on essentially the same plan: a main aisle with a single row on either side for the feeding and housing of stock, with a loft above for storing fodder.

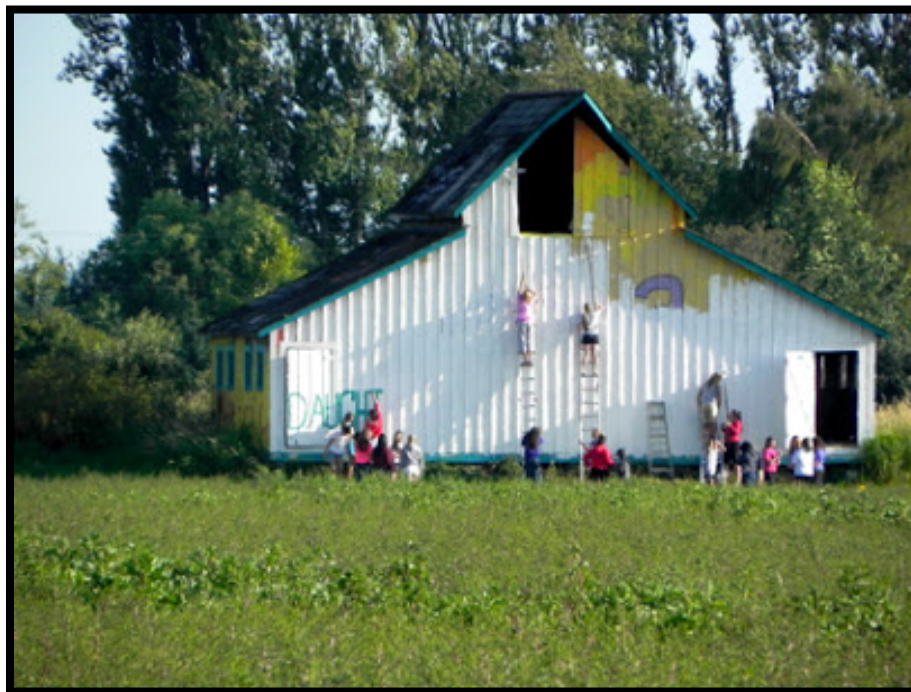
Figure 36: The Memorial Barn being painted over to make way for a new message. Image by Ginger Kauffman.
